MAJOR INCIDENT REPORT FOR 2006

Compiled by
Lameck Betera
Civil Protection Department

1.0 MAJOR EARTHQUAKE SHOOK MOZAMBIQUE, ZIMBABWE AND SA

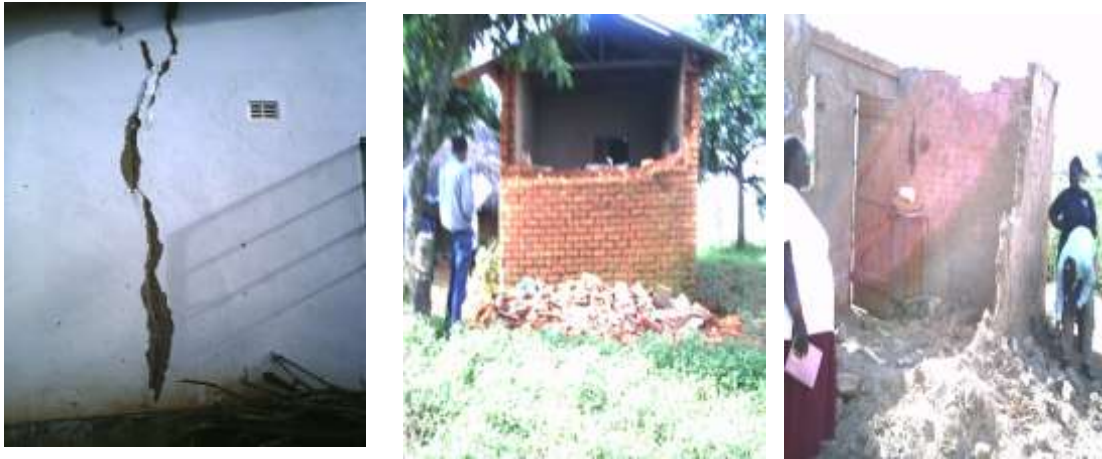
The pictures below show some of the structures which succumbed to the earth quake

Most of the structures which include classroom blocks, administration blocks, toilets , and teachers houses developed cracks and some even collapsed. Some villagers also lost their dwelling units mainly huts.

According to the findings of the assessment, the damage that was caused by the earthquake included development of cracks on building walls, separation of walls at corners and T-junctions, separation of poorly constructed roof from walls, which could lead to the eventual collapse of roof and, disintegration of walls and eventual collapse or future possible collapse of the whole structure.

The assessment team noted that most of the dwelling units which succumbed to the earthquake were poorly built. A salient feature was the use of low cost construction methods and materials, which later failed under stress and age.

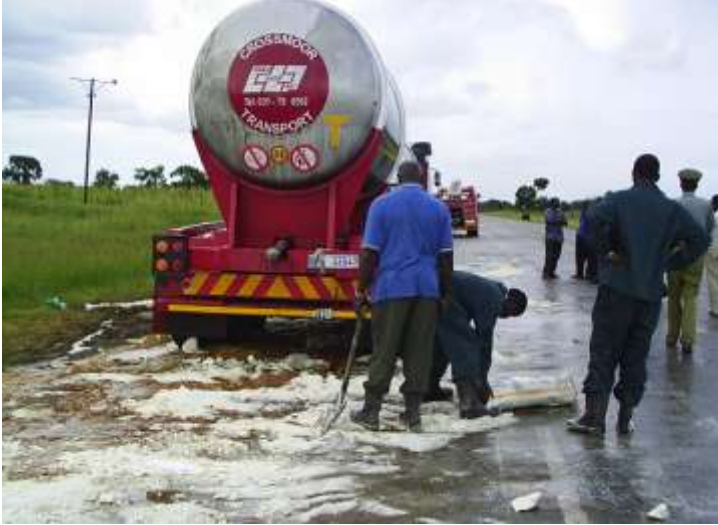
The picture below is tanker which lost sulphuric acid and members from Various organizations who responded to the scene to contain the spillage.

The tanker was parked about 12km away from Murombedzi Growth Point on the Chinhoyi/Chegutu highway. The tanker capacity is in excess of 27 000 litres although the leakage was not excessive. The vehicle was immobilised at the spot on the advice of the owners in South Africa to minimize the spread of the acid and to enhance the institution of intervention measures.

- the scouting for lime or any other alkali recommended for neutralizing the acid;
- the conducting of public awareness in the locality and
- the continual chemical analysis of the water in and around the pollution site.

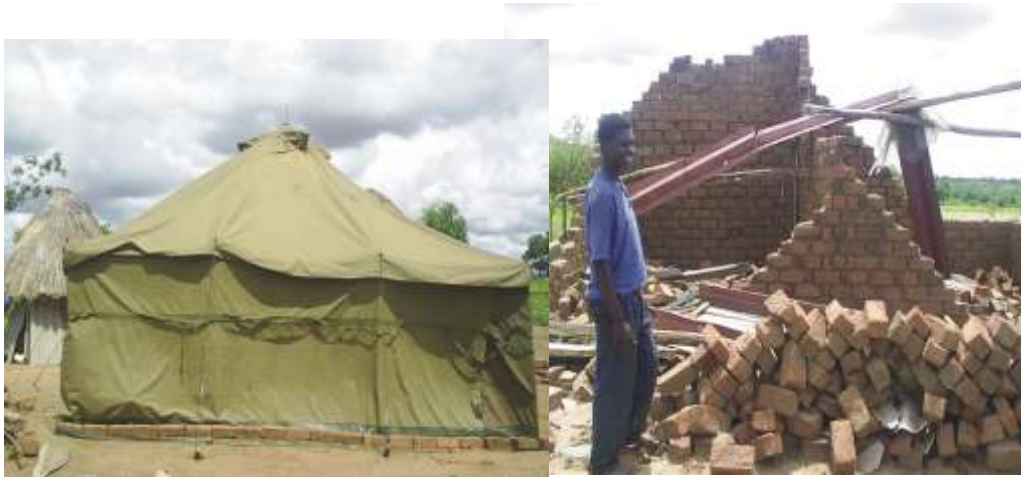
The picture below shows one of the house hold structures which was completely destroyed. Some of the family members are now living in a tent supplied by ZNA.

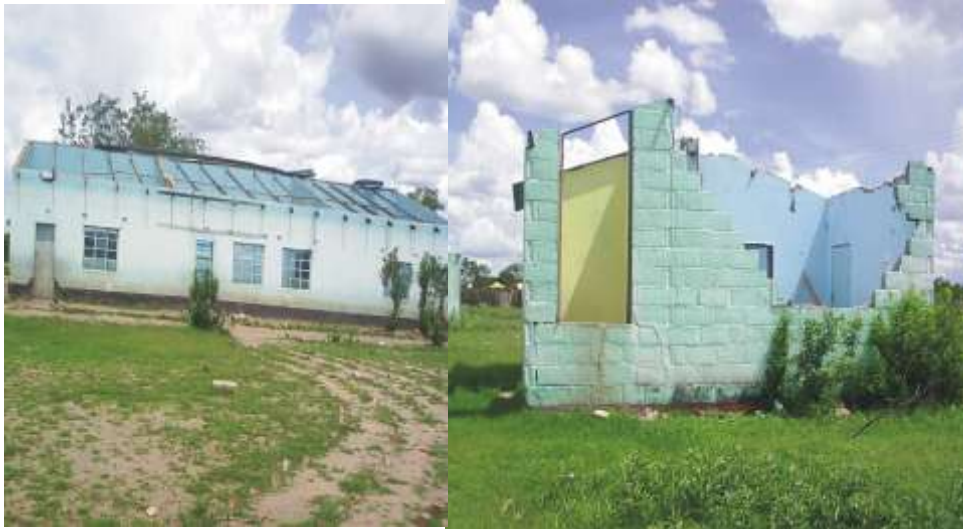
Five classroom block of Mvundlana Primary school had their roofs blown off and asbestos sheets crumbled. Window panes were shattered, learning and teaching material and furniture was damaged. Electric cables and telephone lines were broken.

The school has an enrolment of 721 pupils out of which 600 pupils were affected as their classrooms were damaged. The affected were grades 1,2,3,4, and 7. Six teachers' houses were affected with their roofs blown off and one of them had collapsed walls. Two of the houses developed cracks which rendered them inhabitable

The picture below show a classroom block and a teacher's house that were damaged by the storm.

- There is need to have regular inspections to buildings particularly in public institutions,
- Regular maintenance of buildings is needed,
- Construction Engineers need to provide advice on recommended structures in disaster prone areas.
